Manhole Inspection Summary

Manhole # S21G1_009MH

Insp Date: **4/29/08 9:28 AM**

Location Address: **2419 banger st**

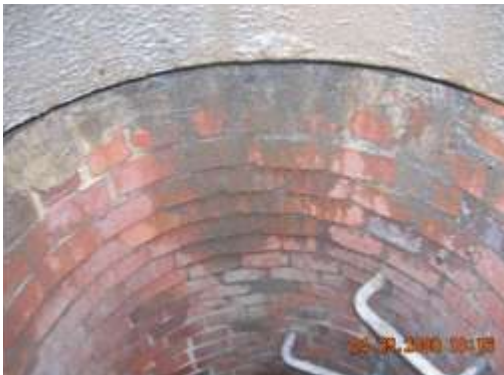
Defect 5

Infiltration: ☐ None ☒ **Joint** ☐ Cracks ☐ Mortar ☐ Roots ☐ Wall

infiltration @ chimney/frame joint

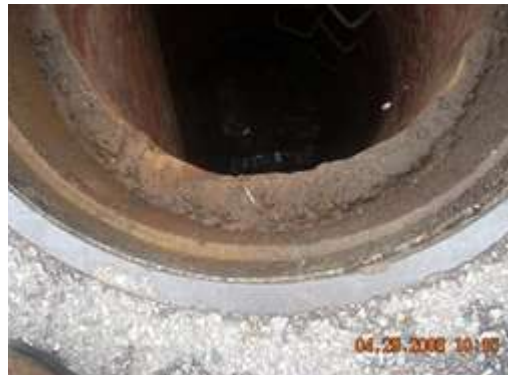
Defect 4

Offset: **3** (in.)

frame offset

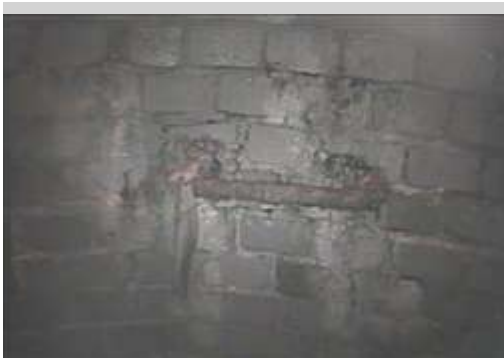
Defect 3

☒ **Evidence Of Surcharge** Depth: **5** (ft.) ☐ Active Surcharge Present

surcharge evidence

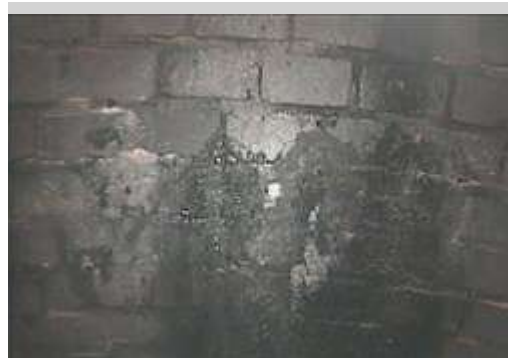
Defect 2

Infiltration: ☐ None ☐ Joint ☐ Cracks ☒ **Mortar** ☐ Roots ☒ **Wall**

infiltration @ barrel wall

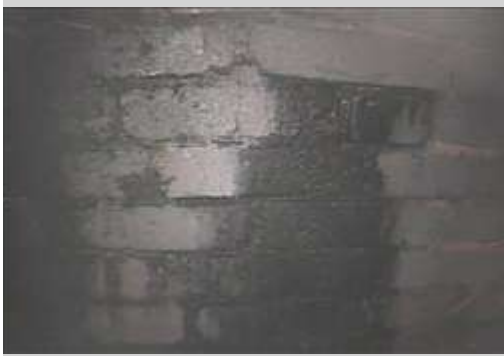
Defect 1

infiltration of mortar @ barrel

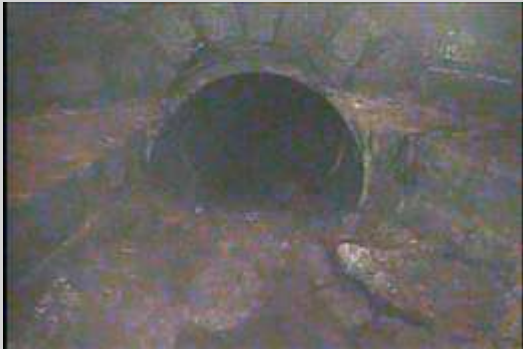
12 O'Clock Outflow

Pipe Height: **12** (in.) Rod and Bar (Angled)
Pipe Material: **Clay** ☐ Pipe Lined
Invert Depth: **19.45** (ft.) Flow Characteristics: **Fast**
Deposits: ☐ None ☐ Mud ☐ ~~Gravy~~ ☐ Debris ☒ Grease
Silt Depth: **3** (in.) Deposits Extent: **Light**
Infiltration: **Evidence** Pipe Seal Cond: **Cracked**

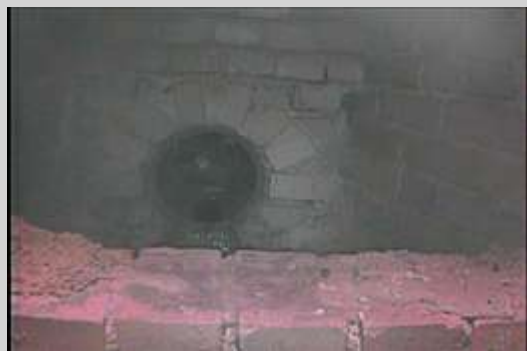
9 O'Clock Inflow

Deposits: ☐ None ☐ Mud ☒ **Sludge** ☒ **Debris** ☒ **Grease**

Silt Depth: **3** (in.) Deposits Extent: **Medium**

Infiltration: **Evidence** Pipe Seal Cond: **Unknown**
